Manhole Inspection Summary

Manhole # S39W1_012MH

Insp Date: **3/27/09 4:42 PM**

Location Address: **427 Maude Ave** Cross Street: **5th St./427 Maude Ave**

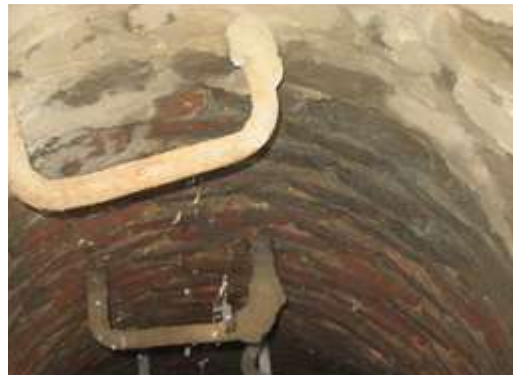
Defect 5

Steps Count: **6** Missing: **1** ☒ **Corroded**

missing step

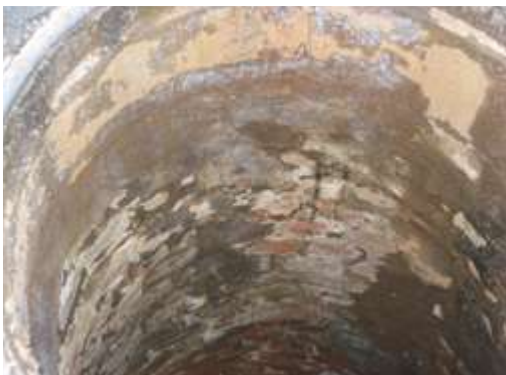
Defect 2

Condition: ☐ Sound ☒ **Cracked** ☐ Root Intrusion ☒ **Loose Brick** ☐ Deteriorated

Infiltration: ☐ None ☐ Joint ☒ **Cracks** ☐ Mortar ☐ Roots ☐ Wall

Chimney cracks/Infiltration

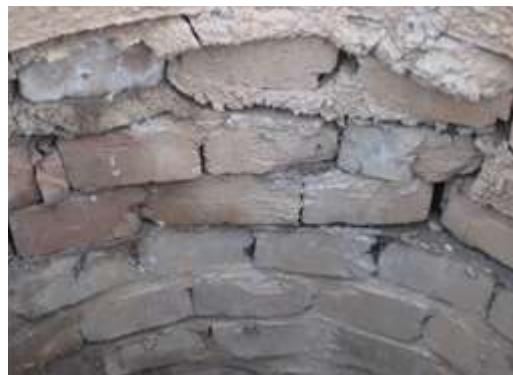
Defect 4

loose bricks

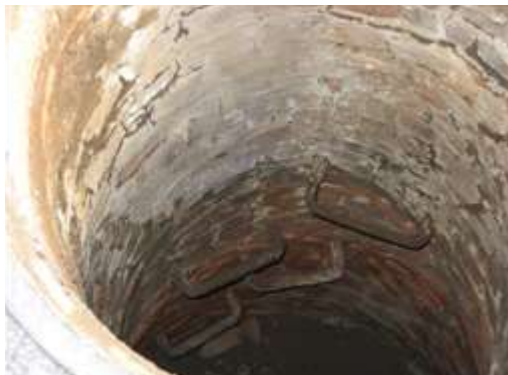
Defect 1

Missing and corroded steps

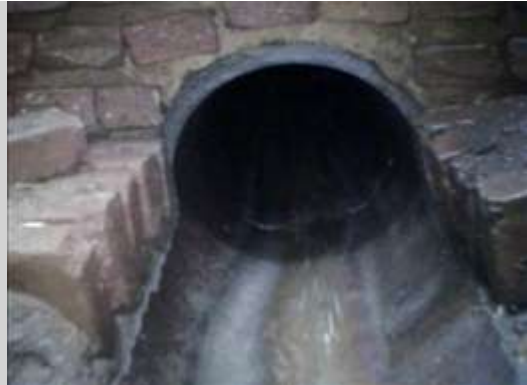
12 O'Clock Outflow

Pipe Height: **12** (in.) Rod and Bar (Angled)
Pipe Material: **Clay** ☐ Pipe Lined
Invert Depth: **12.00** (ft.) Flow Characteristics: **Fast**
Deposits: ☒ None ☐ Mud ☐ Sludge ☐ Debris ☐ Grease
Silt Depth: (in.) Deposits Extent:
Infiltration: **None** Pipe Seal Cond: **Sound**

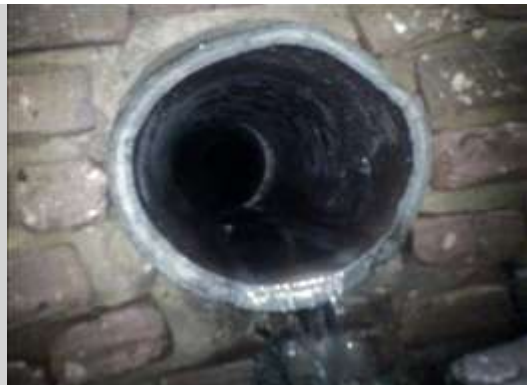
3 O'Clock Inflow

Pipe Height: **10.8** (in.) Rod and Bar (Angled)
Pipe Material: **Clay** ☐ Pipe Lined
Invert Depth: **11.40** (ft.) Flow Characteristics: **Slow**
Deposits: ☒ None ☐ Mud ☐ Sludge ☐ Debris ☐ Grease
Silt Depth: (in.) Deposits Extent:
Infiltration: **None** Pipe Seal Cond: **Sound**

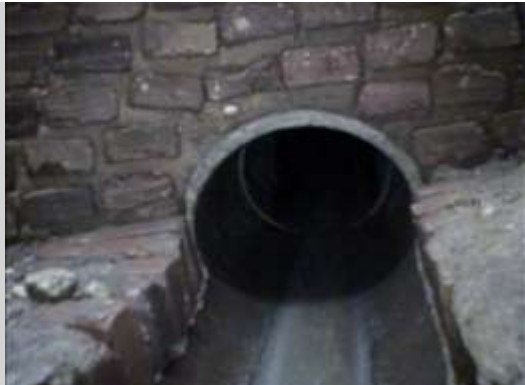
6 O'Clock Inflow

Pipe Height: **10.8** (in.) Rod and Bar (Angled)

Infiltration: **None** Pipe Seal Cond: **Sound**
